## Concrete quality in pig farms

– Is reuse an option?

Rapport 10

Lisbeth M. Ottosen & Ana T. Lima, 2022

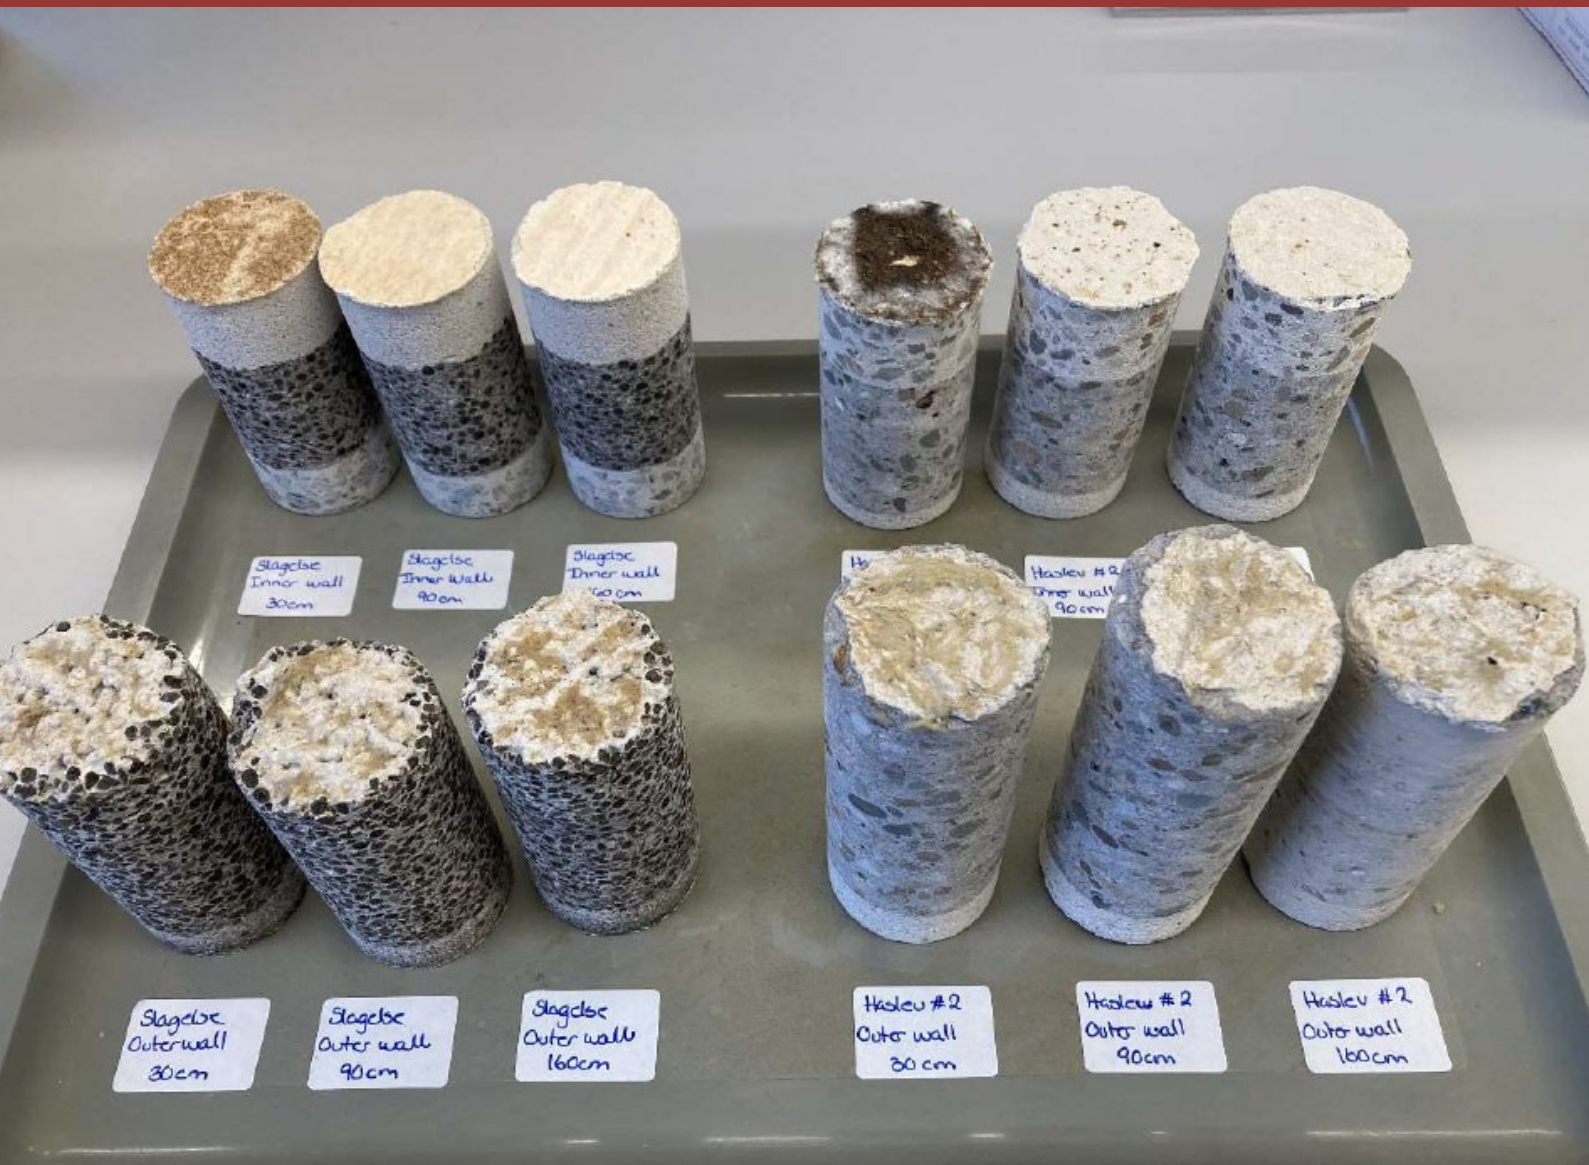
Cover photo:     Core samples from two investigated stable

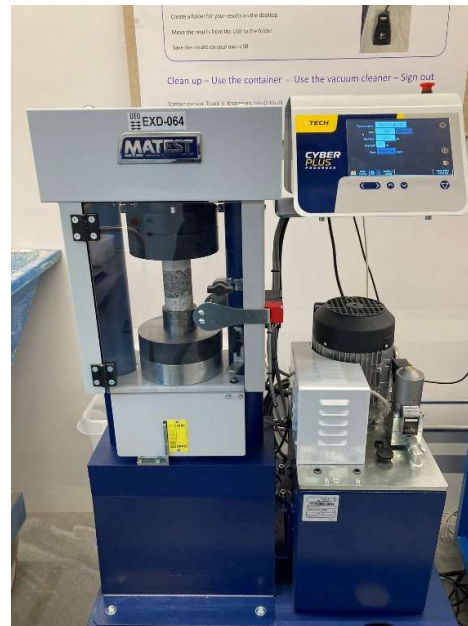
The compressive strength of the core samples was measured on a MATEST Cyber Plus Progress - model: E161 (Figure 3) with a load speed of 1.2 kN/sec.

Figure 3: MATEST Cyber Plus Progress used for compressive test measurements

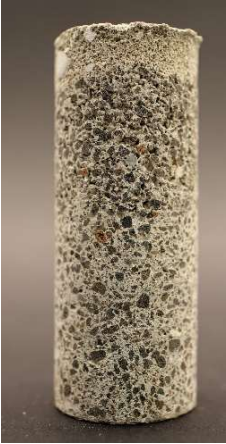
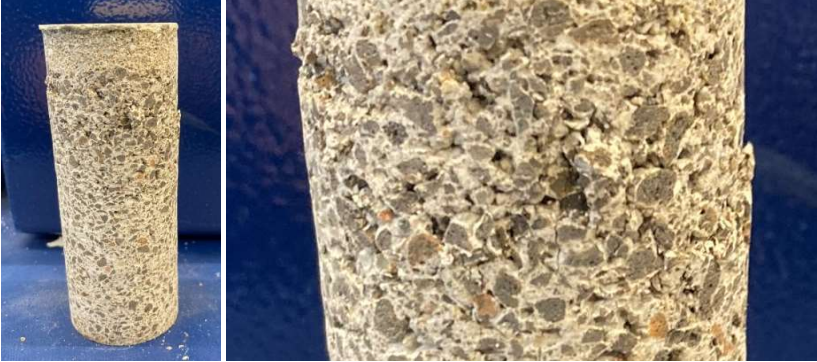
<b>Stable A</b>	Core samples inner wall
Inner wall	<p>155 cm</p>

- Stable A - Inner wall (Figure 5). The core sample had two layers; a plaster layer of about 1.5 cm and a lightweight aggregate concrete (about 8.5 cm). The expected 1 cm of concrete was not present.
- Stable B – Outer wall (Figure 6). The core sample had two layers: a plaster layer of about 2 cm and a lightweight aggregate concrete of 8 cm. This is as expected.
- Stable B – Inner wall (Figure 7). The core samples had three layers: A layer of plaster about 2.5 cm, a layer of lightweight aggregate concrete (about 5 cm) and a layer of concrete (about 2.5 cm). The three layers were as expected, however the mutual thicknesses of the layers were slightly different as the plaster and concrete layers were expected to be 1 cm thick and the lightweight aggregate concrete 8 cm.

<p>Expected composition: 10 mm. plaster, 80 mm. pimpsten/letbeton, 10 mm. beton LC 20-25 / 1600</p>
Compressive strength test

<p>Compressive strength at 155 cm: 5.2 MPa</p>

*Figure 5: Core sample from 155 cm height in Stable A. Pictures from before and after compressive strength test, the expected layers in the sample in relation to Appendix A, and the compressive strength test measured.*

The compressive strength of the core sample from 155 cm height was 5.2 MPa. It is seen from Figure 5 that the core sample broke in the depth of about 3-4 cm into the sample in a layer parallel to the surface, i.e. in the matrix of lightweight concrete. Since the compressive strength was 5.2 MPa, i.e. a low strength compared to the typical values. The lightweight concrete might have lost strength in this height in the use period, which is likely considering the broken specimens from the other depths. The density of the four pieces of the broken core specimens from 20 and 91 cm height (Figure 2a) was between 3.6 and 4.2 kg/m<sup>3</sup> (average 3.8 kg/m<sup>3</sup>) which is also low compared to the typical values. The reason may be degradation of the cement phases in the harsh environment during the lifetime of the stable.

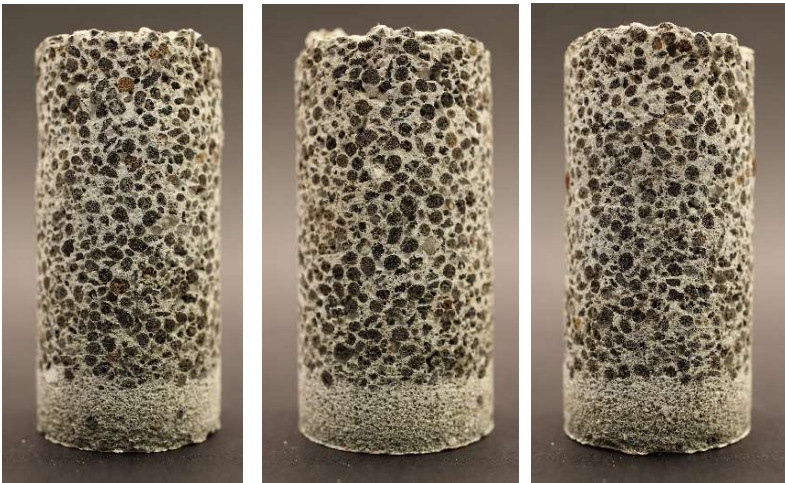
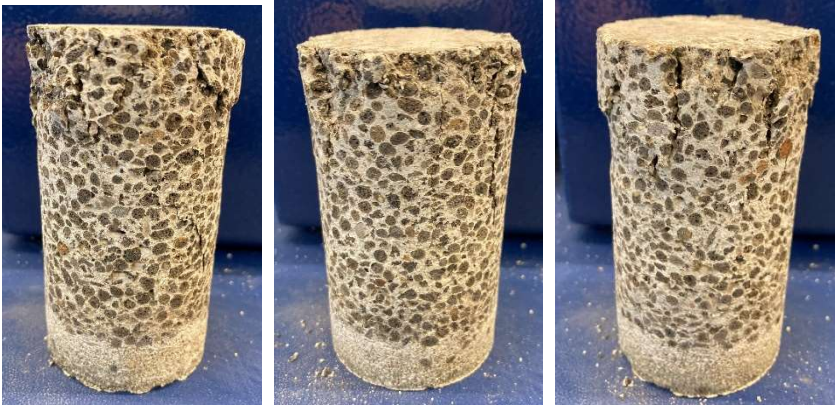
<b>Stable B</b>	Core samples outer wall
	<p>30 cm                      90 cm                      160 cm</p>

<p>Expected composition: 10 mm. pudslag, letbeton 90 mm. Våd støbt, LC16/1600, Armering, plastfibre</p> <p>The element were 26 cm thick in total, and consist of 10 cm. inner wall/concrete, 10 cm. mineral insulation and 6 cm. outer wall concrete.</p>
Compressive strength test

<p>30 cm: 5.3 MPa  90 cm: 6.1 MPa  160 cm: 5.0 MPa</p>

Figure 6: Core samples from Stable B outer wall. Pictures from before and after compressive strength test, the expected layers in the sample in relation to Appendix A, and the compressive strength test measured.

The core samples from the *outer wall* of Stable B had two layers (plaster and lightweight concrete) and it broke in the lightweight concrete. The compressive strengths were at 30 cm height 5.3 MPa, at 90 cm height 6.1 MPa and at 160 cm height 5.0 MPa. The average being 5.5 MPa.

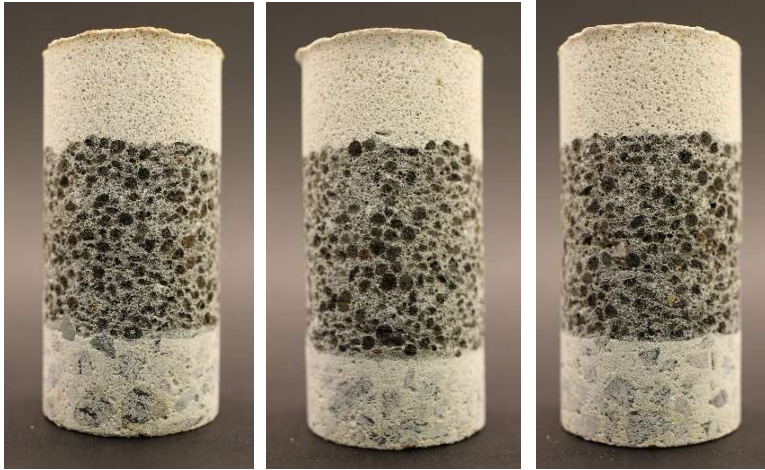
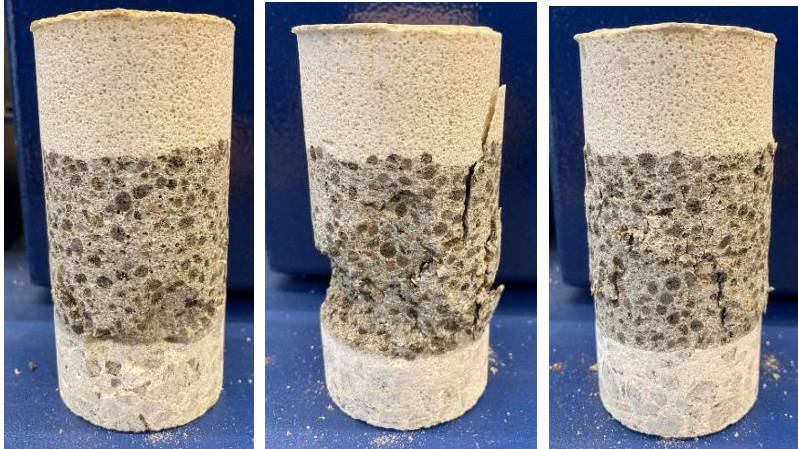
<b>Stable B</b>	Core samples inner wall
	<p>30 cm                      90 cm                      160 cm</p>

10 mm. puds, 80 mm. pimpsten/letbeton, 10 mm. beton, LC 20-25/1600
Compressive strength test

<p>30 cm: 6.7 MPa  90 cm: 8,8 MPa  160 cm: 12,4 MPa</p>

Figure 7: Core samples from Stable B inner wall. Pictures from before and after compressive strength test, the expected layers in the sample in relation to Appendix A, and the compressive strength test measured.

The core samples from the *inner wall* of Stable B, which were composed of three layers, did have the lowest compressive strength in the middle layer of lightweight concrete. The sample from 30 cm height broke mainly in the interphase between plaster and lightweight concrete, whereas the two other core specimens broke in the layer. Due to this, the compressive strength of the three cores reflect the strength of the layer of light way concrete: at 30 cm - 6.7 MPa, at 90 cm - 8,8 MPa and at 160 cm - 12,4 MPa. The average was average 9.3 MPa.

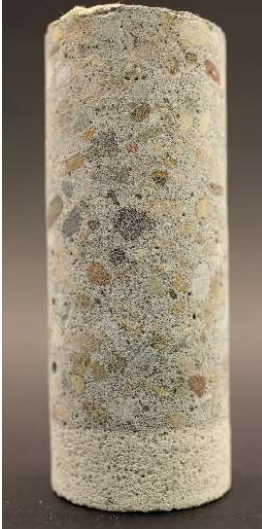
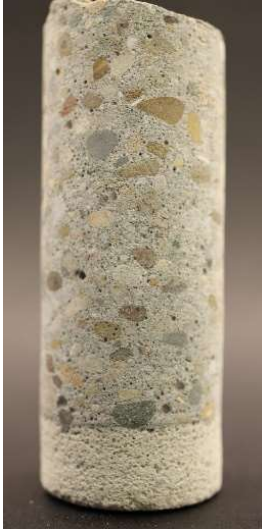
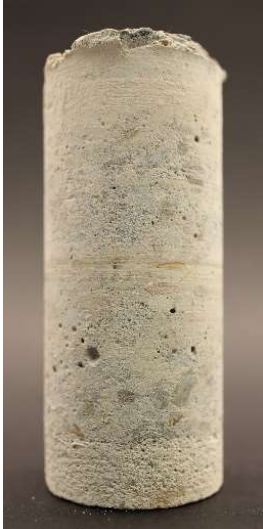
<b>Stable C</b>	Core samples outer walls		
Outer Wall	30 cm	90 cm	160 cm

- Stable C – Outer wall (Figure 8). The core samples had two layers: plaster of 1.5 – 2 cm. and a layer of concrete. This was as expected.
- Stable C – Inner wall (Figure 9): The core samples had about 1 cm plaster, 6 cm of grey concrete and 3 cm of white concrete. Except from the plaster, this was as expected.

10 mm. pudslag, 90 mm. Traditionel vådstøbt beton som bagmur LC25/2400 Armering Y6 / 200 mm.		
Compressive strength test	 		
	30 cm: 32.8 MPa 90 cm: 36.6 MPa 160 cm: 32.4 MPa

Figure 8: Core samples from Stable C outer wall. Pictures from before and after compressive strength test, the expected layers in the sample in relation to Appendix A, and the compressive strength test measured.

The strength of the core samples from the *outer walls* were in 30 cm - 32.8 MPa, in 90 cm - 36.6 MPa and in 160 cm - 32.4 MPa. The average being 33.9 MPa.

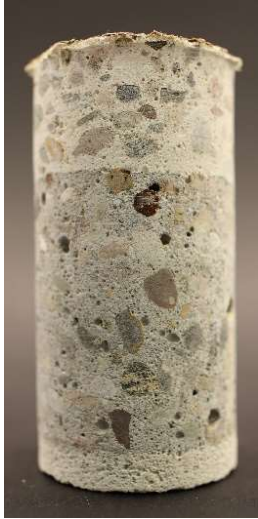
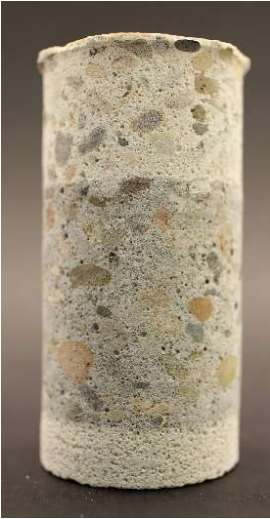
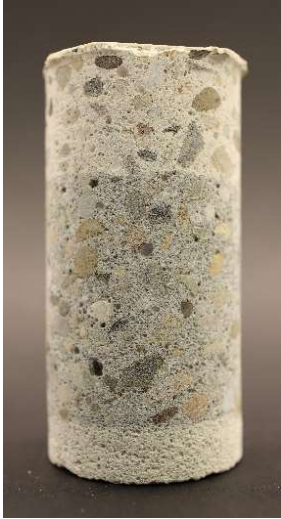
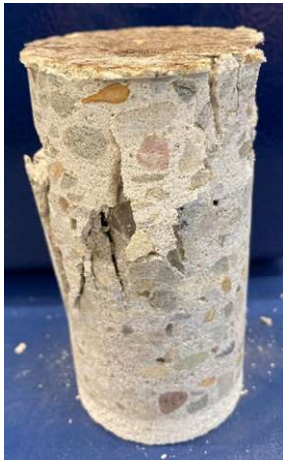
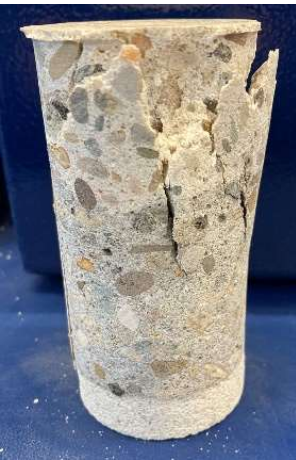
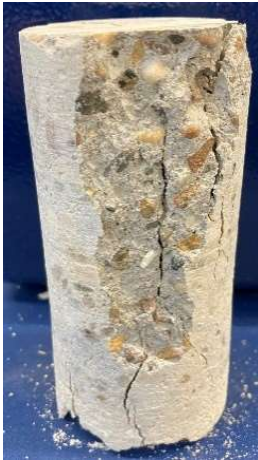
<b>Stable C</b>	Core samples inner walls
	<div style="display: flex; justify-content: space-around;"> <div style="text-align: center;"> <p>30 cm</p>

</div> </div>
	<p>20 mm. hvid, 90 mm traditionel vådstøbt beton som bagmur LC25/2400 Armering Y6 / 200 mm.</p>
	<div style="display: flex; justify-content: space-around;">

</div>
	<p>30 cm: 32.1 MPa 90 cm: 40.8 MPa 160 cm: 41.7 MPa</p>

Figure 9: Core samples from Stable B inner wall. Pictures from before and after compressive strength test, the expected layers in the sample in relation to Appendix A, and the compressive strength test measured.

The strength of the core samples from the *inner walls* were in 30 cm - 32.1 MPa, in 90 cm – 40.8 MPa and in 160 cm – 41.7 MPa. The average being 38.2 MPa.

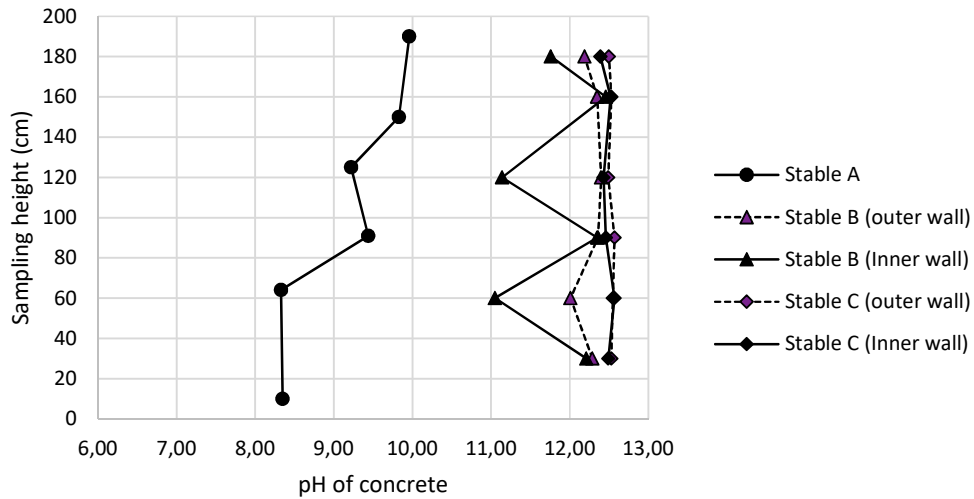
Figure 10: pH in the drilling powder samples from the investigated walls

The pH is interesting in relation to protecting the reinforcement steel towards corrosion. The cement in concrete has a high pH, usually around 13-14. At such high pH, the passive layer on the reinforcement steel is intact and the steel is protected towards corrosion (unless  $\text{Cl}^-$  is present). The passivation effect protecting the steel is lost at around pH 9.5 to 10.5. The pH in the wall from Stable A has a too low pH for the reinforcement steel to be protected ( $<10$ , see Figure 10), and this corresponds well to the found corrosion of the reinforcement bars in the core samples (Figure 2a). In the walls from Stables B and C, the pH was high enough to expect passivation of the reinforcement.

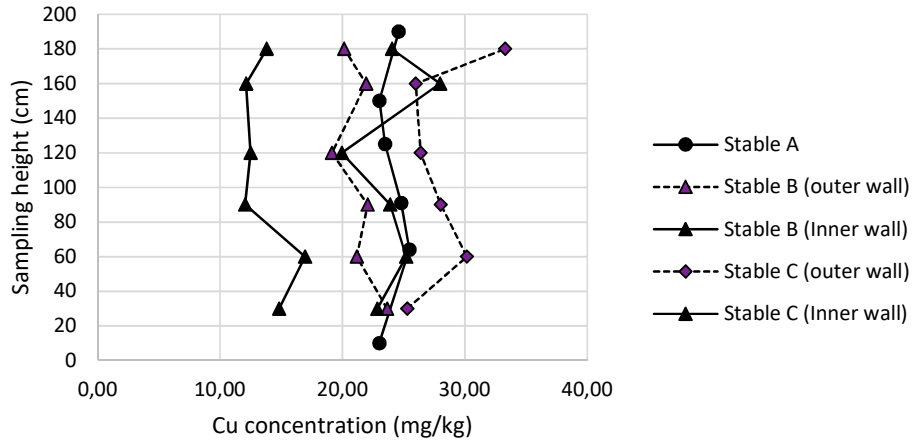
Pig manure contain copper and zinc, which has received attention as problematic to spreading the manure at agricultural land (Landbrugsavisen 2015). High concentrations in the walls of these toxic heavy metals could hamper reuse. However, the concentrations of the two heavy metals in the powder samples from the investigated walls are all at a relatively low level, and is not considered problematic in case reuse of the walls is planned.

Figure 13: Copper concentration in the drilling powder samples from the investigated walls
